EKLUTNA RIVER SALMON HABITAT ASSESSMENT AND COLLABORATION TO RECOMMEND RESTORATION FLOWS 2020

Native Village of Eklutna

Stream Survey 2019

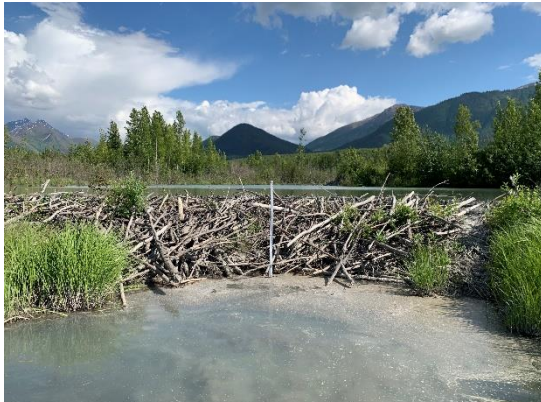
Largest Beaver Dam in Reach 2. Dam approximately 4 ½ feet high.

Reach 2 appears to have had good pond rearing habitat for juvenile salmonids when it was assessed. Subsequent visit found the upper beaver dam ponds much lower when the river was lower and not feeding them. Increased flow could maintain all these ponds as rearing habitat year-round. Spawning has been observed in Reach 2. With sufficient flow beaver dams could enhance overwintering habitat for salmon but at current flow the beaver dams make salmon passage more challenging by dewatering otherwise passable habitat.

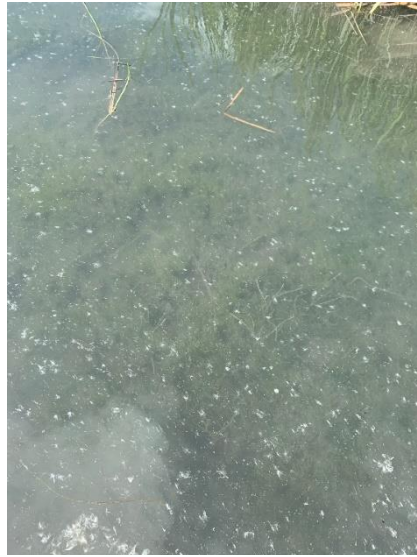
Aquatic Vegetation in Reach 2

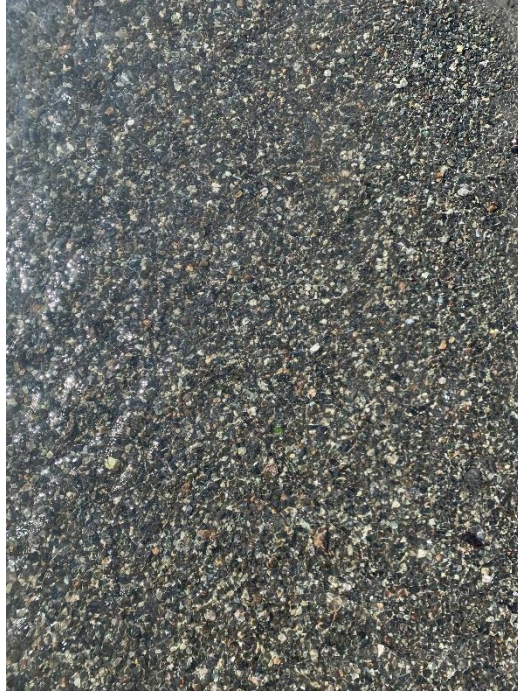
Substrate in Reach 3 was mostly embedded gravel. This section was split into two equal channels that each were braided before all coming back together. Braiding seemed unstable in this section with clear channels defined, but water depth was shallow in all the channels. Not many pools were observed in this reach, but bank vegetation and in-stream debris were observed. Not all of the reach has sufficient depths to allow more than adults to pass through.

Substrate in Reach 3 – Imbedded gravel

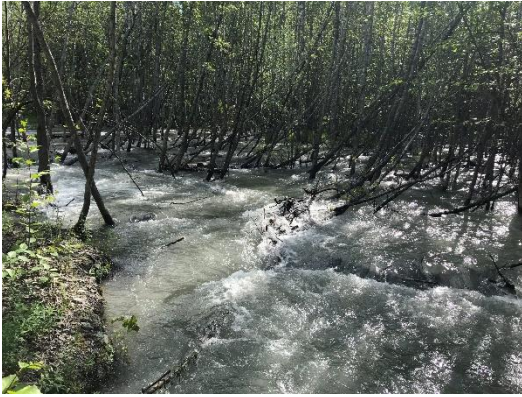
Above and Right: Flooded forest unit with no clear channel.

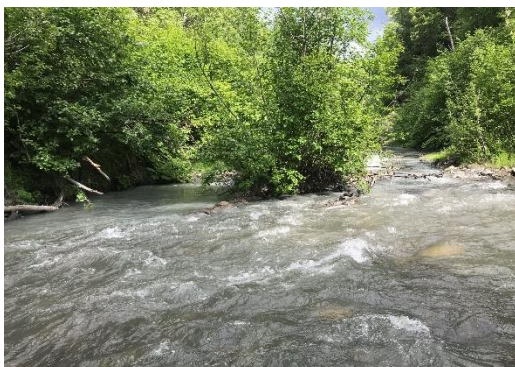
The confluence of Thunderbird Creek to the right. Eklutna River continues to the middle, with a pool on the left.

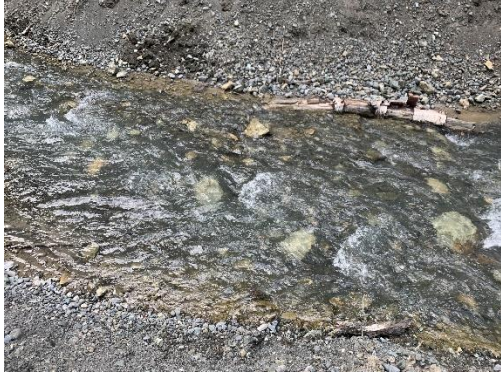
Chum salmon and a few coho have been observed spawning in the lowest units of Reach 6 (ADF&G communications). Rocky obstructions prevent their passage farther upriver under low flow. Juveniles have also been observed rearing in these lower units. We believe this reach has good spawning and rearing potential with higher and flushing flows.

Substrate and water clarity in Reach 6.

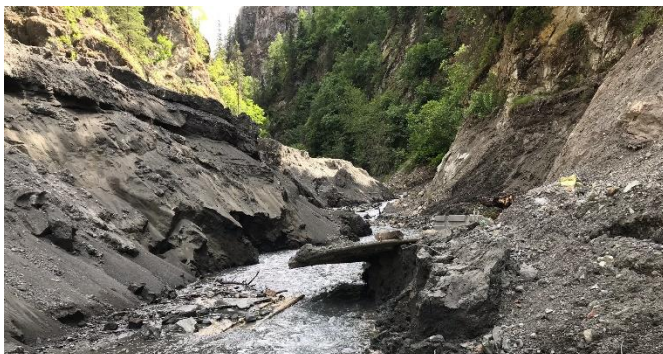
An area behind the removed lower dam. Silt still towers approximately 20 feet from the surface of the water.

At the beginning of the reach, silt walls line the canyon, leftover from the dam demolition. These banks will add sediment as they are worn down. A small rockslide created a natural bottleneck. This area was dammed in the past and had pools over 5 feet deep. Currently, the area is free of debris and/or beaver dams. Colluvial slides are observed more frequently in this reach. Juvenile dolly varden have been observed recently in this reach, but salmonids have not been observed recently. We believe

that Reach 7 has good spawning and rearing habitat pending higher sustained waterflows. More flow is required for fish passage and to erode continuous deposits from the canyon wall that obstruct flow as well as dam backfill.

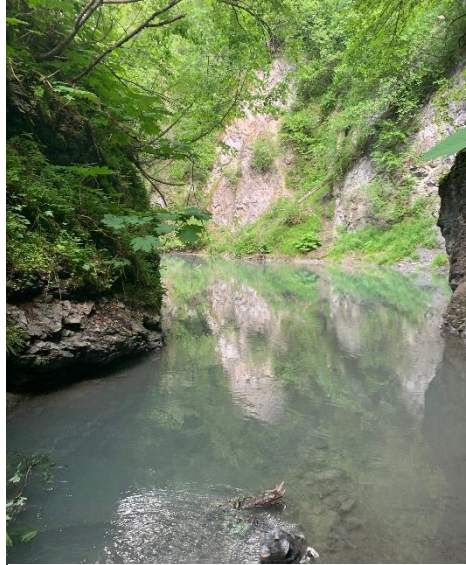
An existing pool in the canyon

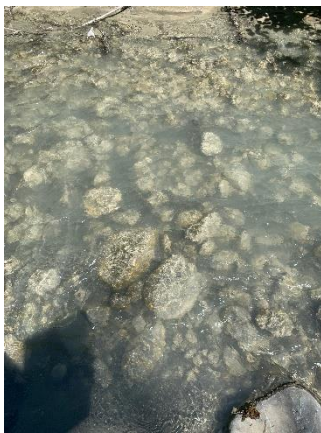
Cobble substrate with algae growth

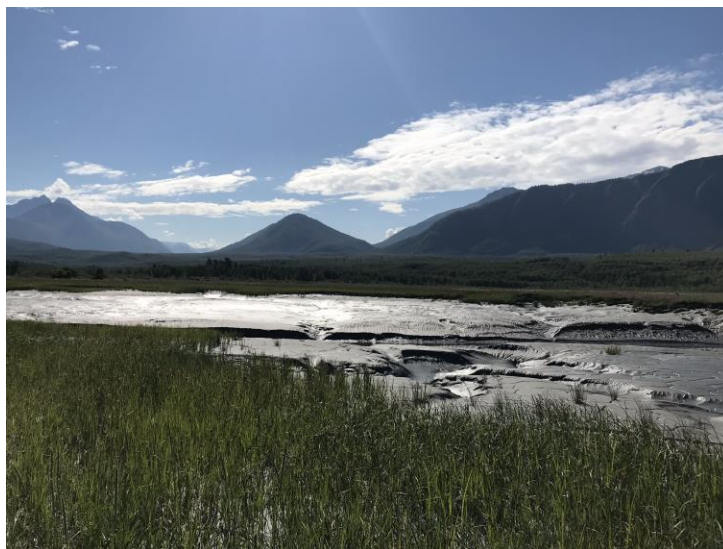
Above: The mouth of the Eklutna River looking upstream
Below: The mouth of the river looking at the inlet

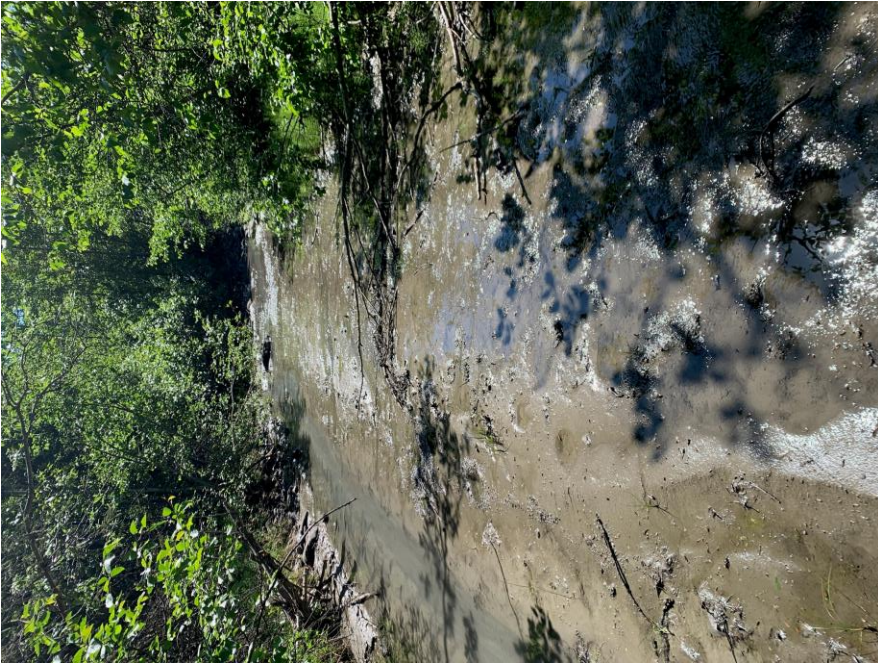
Unit 106.0 – Glide

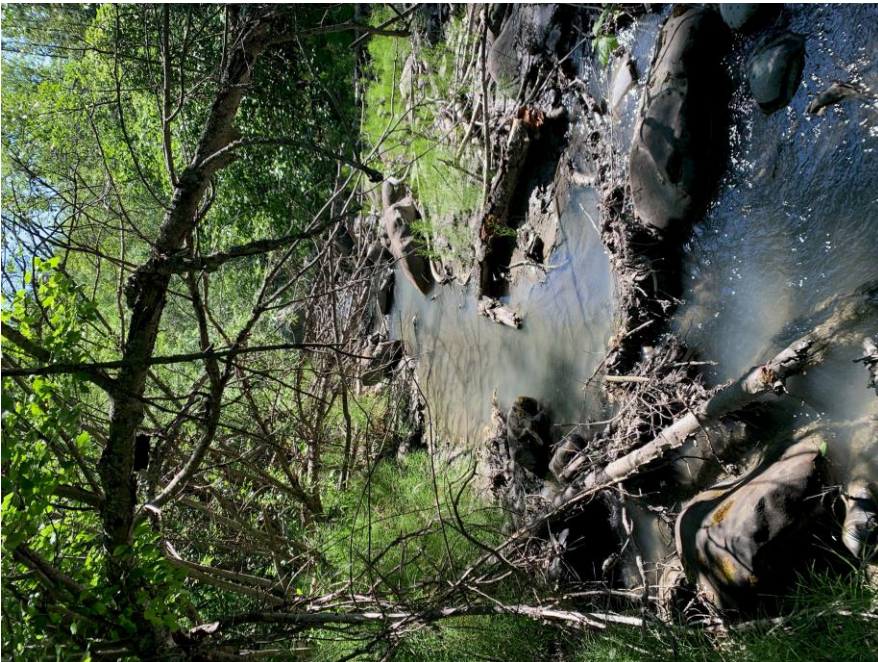
Unit 105.0 – Run
