# EKLUTNA RIVER SALMON HABITAT ASSESSMENT AND COLLABORATION TO RECOMMEND RESTORATION FLOWS

Carrie Ann Brophil, Native Village of Eklutna; Marc Lamoreaux, Native Village of Eklutna

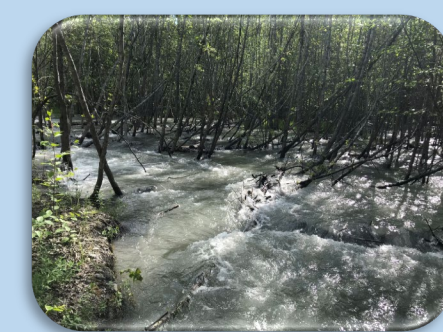
In Reach 4, a flooded forest area with no defined channel. This is between the Glenn Highway bridges and the rail road bridge.

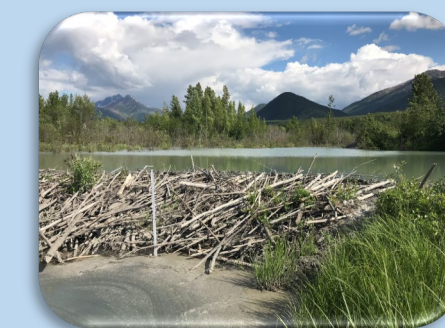
Beaver Dams is various places along the river. These dams provide habitat for salmon, but could also be barriers for salmon.

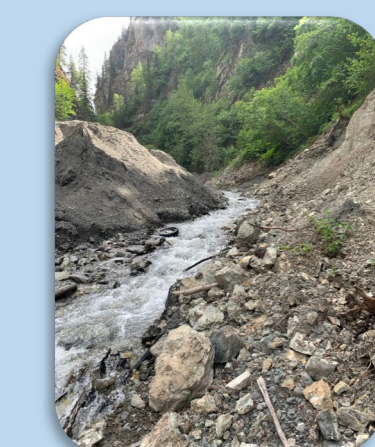
Area behind the lower dam site where there is still a build up of silt. Eventually this silt will wash down the river, more than likely in large amounts at once.
