NATIVE VILLAGE OF EKLUTNA

Native American Lands Environmental Mitigation Program Strategic Project Implementation Plan

March 31, 2015

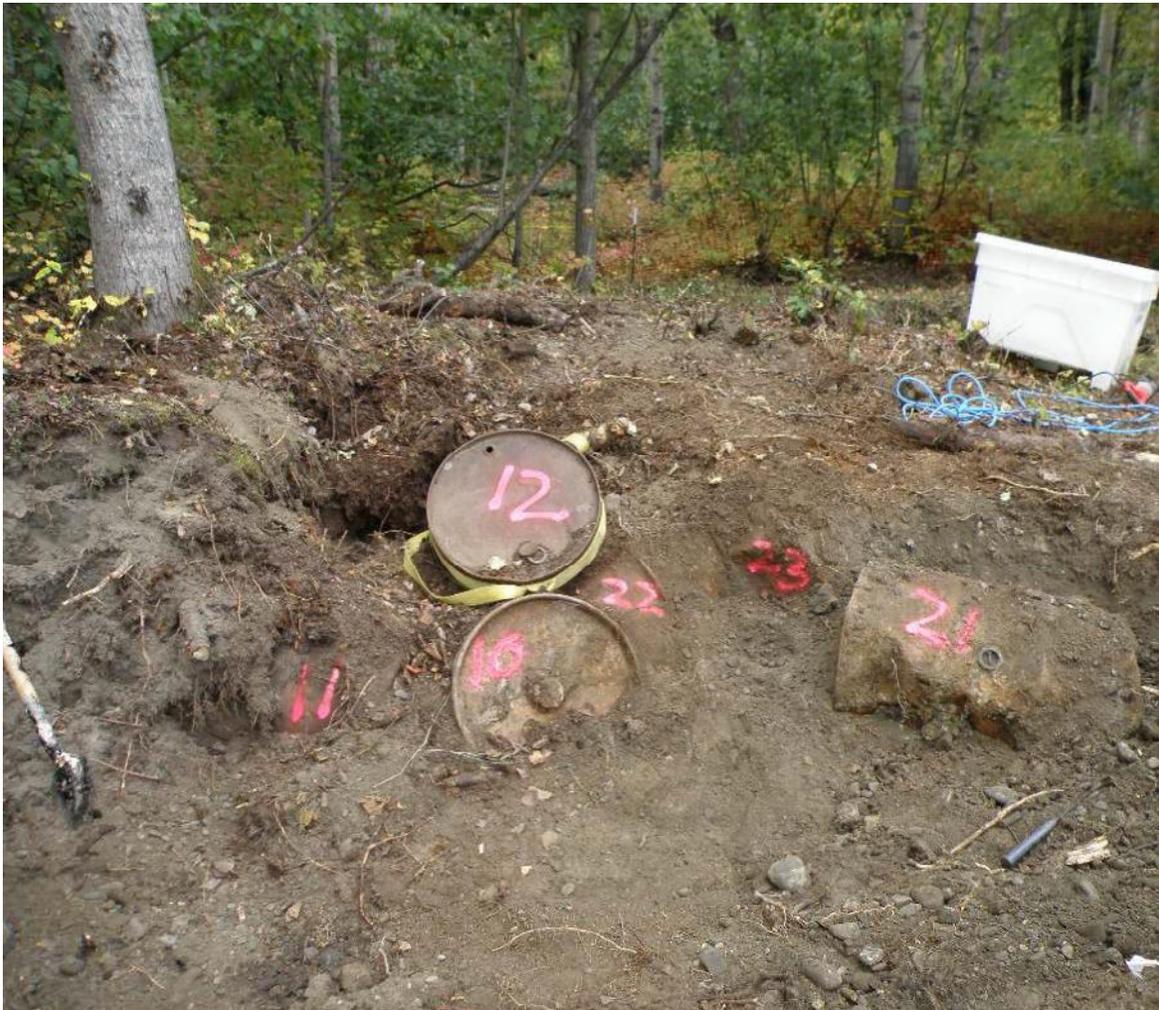
Photo 7: Eklutna Army Site Drum Dump

After the cleanup of 40 drums in 2007, there were still 16 drums visible at the surface and covered by tarps for the duration of 2008 and 2009. Chilkat Environmental assisted preparation of the NVE Drum Dump Interim Removal Action Work Plan July 20. ADEC responded with comments on July 24, which were addressed over the phone and later approved. Fieldwork was performed September 6-20 and included confirmation with metal detectors that all drums had been removed. A total of 62 additional drums with contents were removed. Drums were either excavated manually or pumped in-place to avoid release when disturbed. Refer to photos 7 and 8, which demonstrate the condition of the drums in the ground and challenge of removal. Drums were placed in overpacks and transported to a covered staging area. Once all the drums were staged they were divided into the six products encountered and samples collected to refine waste profiles and manifests. The six products included tar, white paint, green paint, gray paint, solvent and a tar/gasoline mixture. The paint was determined to contain lead and the solvent can be described as Stoddard Solvent that was likely used as paint thinner and to improve paint application in cold.

Drum contents were combined with like materials when feasible, placed in new drums or overpacks, properly labeled with shipping hazard information and transported to Waste

Management Inc. for proper disposal. The final shipment had 54 drums and overpacks [Refer to Photo 9]. Most of the drums were full and contained unused products. Waste was stored, treated and disposed of in compliance with the Solid Waste Disposal Act as amended by the Resource Conservation and Recovery Act. The outcome of each excavated drum with contents was documented in compliance with 18 AAC 75.325(f)(1)(B). Hazardous waste was disposed under EPA Waste Generator ID AKR000203398 and certificates of destruction were filed with EPA.

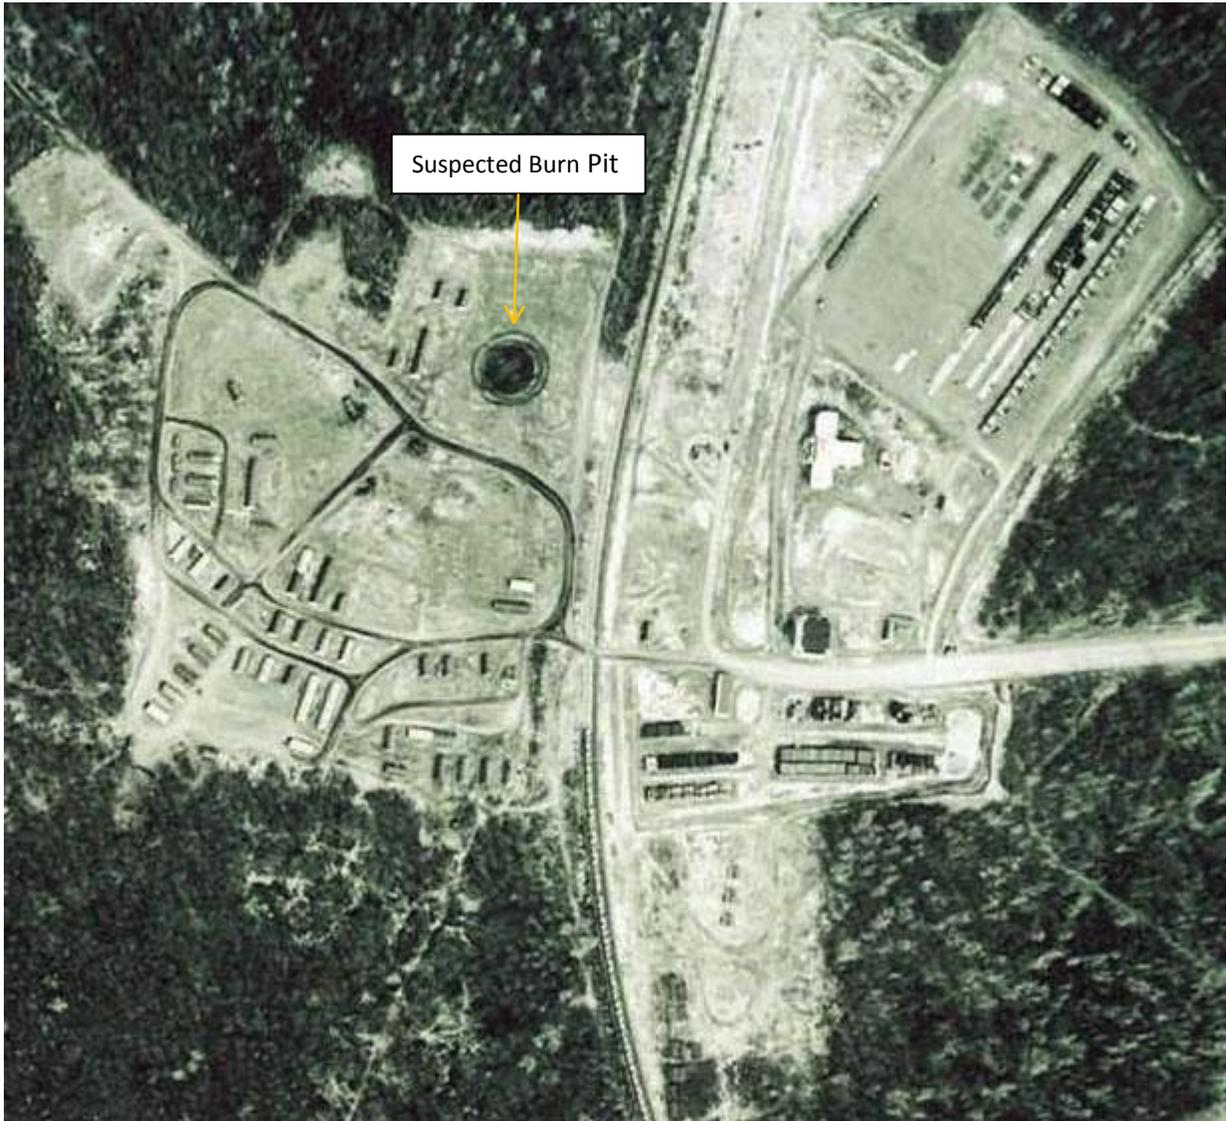
Photo 10: 1964 Eklutna Army Site air photo

The suspected burn pit was a 115-foot circular area, covered by grass and second growth trees. The site is within the clearing between the Pow Wow grounds and the "men's circle" used for ceremonial activities. Its boundary is barely apparent in the field as a shallow, five-foot wide berm concaved toward the center. The suspected burn pit was visible as a blackened circle in a 1964 air photo of the Eklutna Army site. See Photo 10 below.

Preliminary investigation identified the site as a 128-foot diameter circle of birch, white spruce and poplar trees. The perimeter is elevated about six-inches above the surrounding surface. The circle of trees is primarily surrounded by grass and within the circle a cross was observed also dominated by trees. This cross feature was observed to approximately line up with magnetic north in 1964 of 26° east declination. These observations indicate the feature could be aviation related. Test pits were forwarded throughout the site and did not encounter charred debris. Subsurface investigation found characteristics identical to the surrounding landscape. The upper 2-4-inches contained silty soil and organics from grass and shrubs. Beyond four-inches below ground surface featured dense unconsolidated cobble, gravel, sand and silt originating from the former floodplain of the Eklutna River.

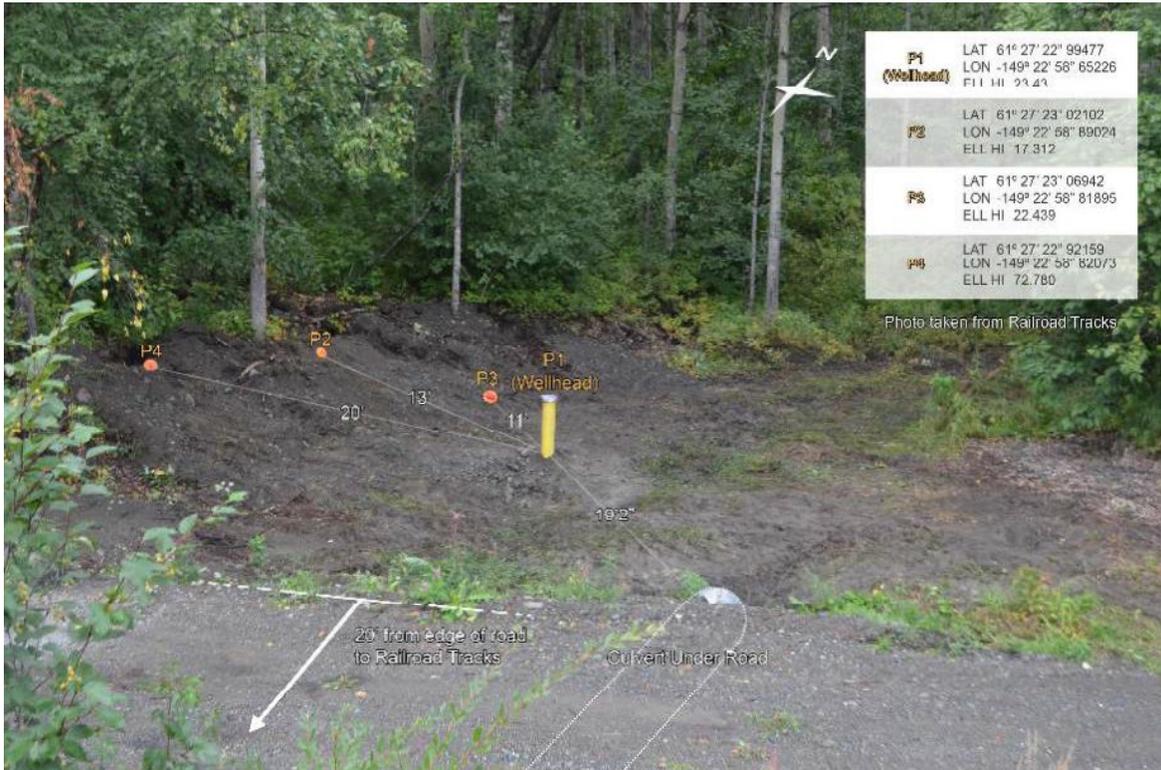
Figure 4: Groundwater well and soil sampling

To further characterize this contamination, the work plan called for three test pits sampled for soil at two-foot intervals. One soil sample was also collected from just above the saturated soil horizon at 18.5 feet during well installation. Groundwater investigation encountered no exceedance of cleanup standards and all results were below detection from the water table at 22-feet below ground surface. Sampling included a duplicate that produced identical results.

Results from two of three test pits and the groundwater interface soil sample at 18.5-feet were below cleanup levels. One of the test pits failed to pass cleanup levels. Contamination was observed at two-feet but not at the surface or at 4 feet. While the result was above the cleanup level, it was marginally above the detection limit. Two samples collected at the same depth at the same time produced one clean and one contaminated sample suggesting contamination was at the minimal extent and that the soil lens was not homogenous.

The ADEC Method 2 migration to groundwater soil cleanup levels per 18AAC75 is intended to protect groundwater that people could ingest. The NVE groundwater investigation performed by Chilkat Environmental explored this human exposure pathway and determined that the pathway is not contaminated. Therefore, under Method 2, the other regulated exposure pathways associated with soil met requirements for closure.
