# EKLUTNA RIVER SALMON HABITAT ASSESSMENT AND COLLABORATION TO RECOMMEND RESTORATION FLOWS

Carrie Ann Brophil, Native Village of Eklutna; Marc Lamoreaux, Native Village of Eklutna

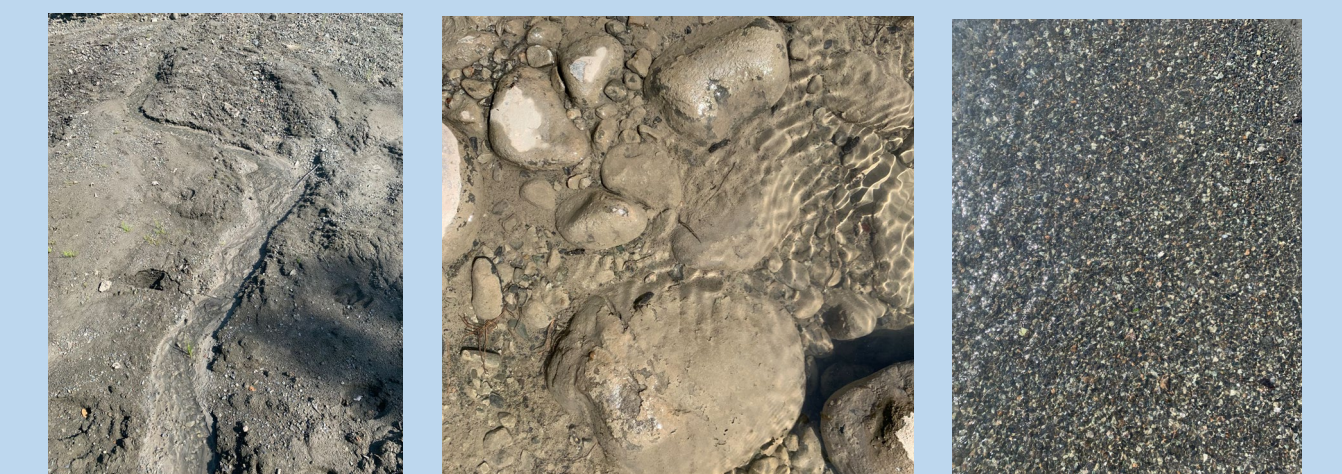
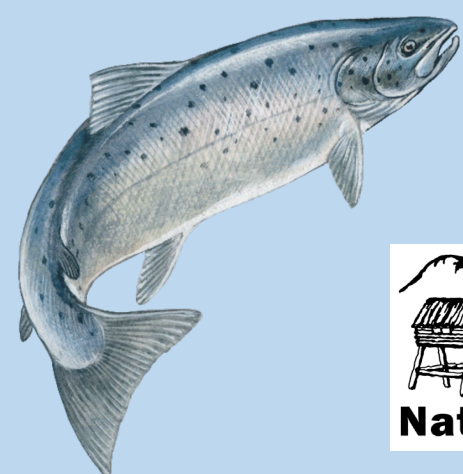
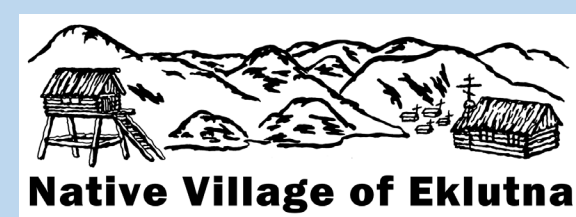
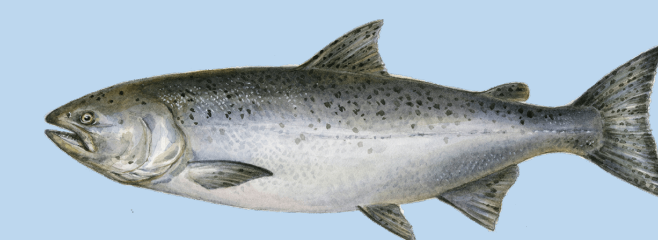
Below: Substrate photos of Eklutna River (not exhaustive): from left to right: silt/clay, Cobble/gravel with silt, embedded gravel.
