EKLUTNA RIVER SALMON HABITAT ASSESSMENT AND COLLABORATION TO RECOMMEND RESTORATION FLOWS 2020

Native Village of Eklutna

Stream Survey 2019

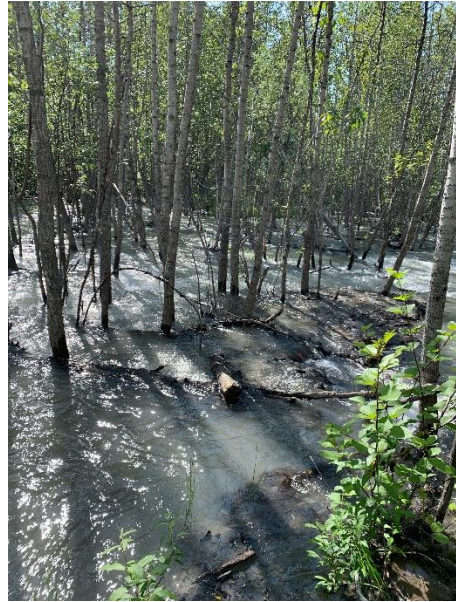
Reach 4 had the highest measured flow rate. This was not expected as the channel width were not significantly different from the previous reaches. A single channel flowed under the railroad bridge and into a section of river that is known for being braided, currently called the flooded forest. In this unit, the water flowed at an increased rate, but was not measured due to the lack of safety equipment to safely accomplish this. In previous years, this unit was observed as a braided section, but due to the high water at the time of the survey, it was not discernable if braiding would still be present at lower flows. A former channel to the south no longer had water and reduced the area of this unit considerably from the 2007 survey. The river came together into a defined channelized section at the Glenn Highway bridges.

Above and Right: Flooded forest unit with no clear channel.

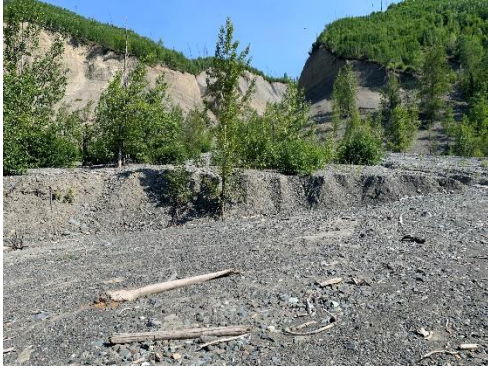
The valley widens in Reach 9, but the river stays channelized through the valley. Active colluvial fans enter the river on the north side and deliver more silt/clay and gravel into the system than low flow has the ability to disperse. The bank vegetation changes from short trees/shrubs to tall trees. Coniferous trees are closer to the river here, but not in high numbers.

An old colluvial slide comprised of gravel and silt. Parts of this slide are still active (right).

Reach 9 needs more sustained waterflow and flushing flows to sustain salmon.

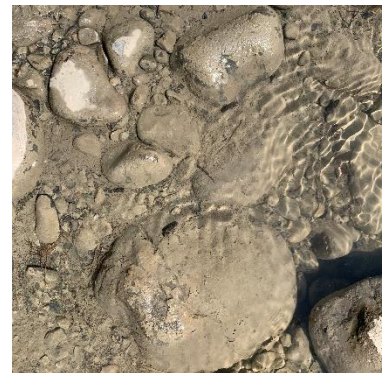
Substrate in a watered section of Reach 11

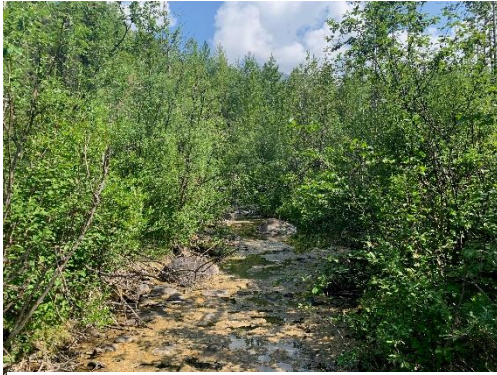
Stagnant ground water with algae growth

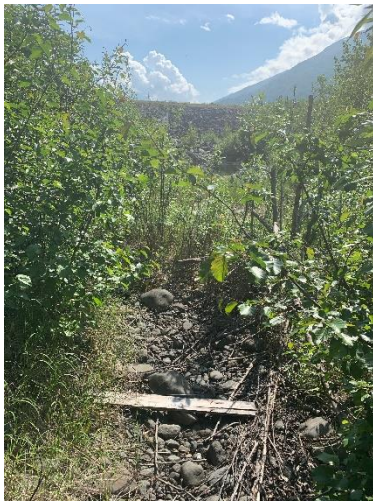
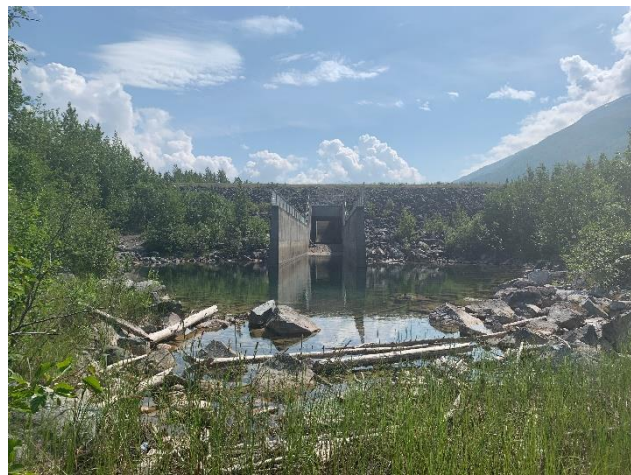
the bank vegetation. Below the Eklutna Lake Dam is a groundwater pool that rarely spills into the river channel.

The area just below the Eklutna Lake Dam. Left: the dry channel on the outside rim of the pool. Right: the pool below the dam

Reach 11 needs more sustained waterflow and flushing flows to sustain salmon.

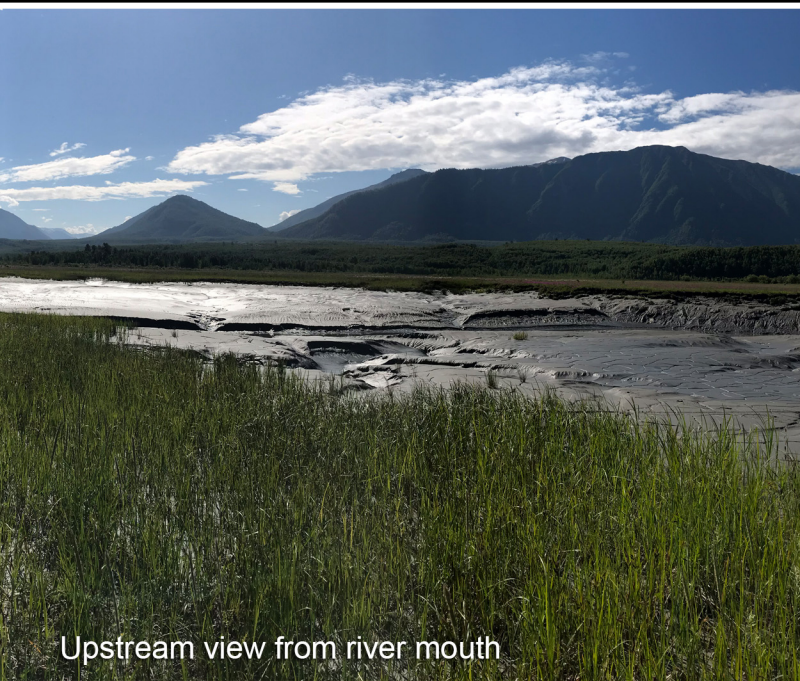
Upstream view from river mouth

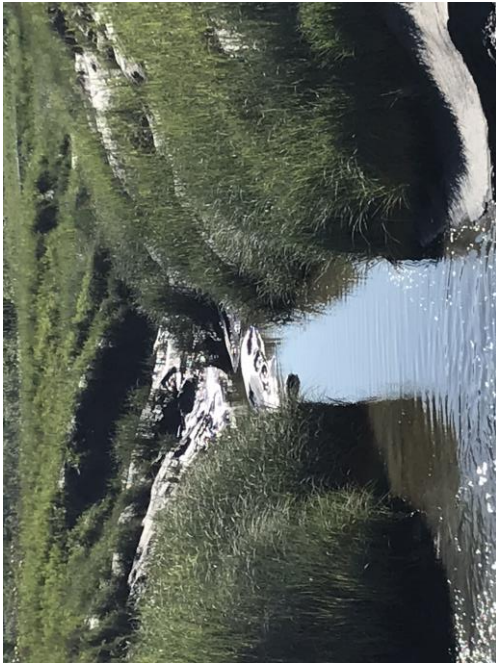
Side channel at start of Unit 4 – a tidal channel with no other apparent water source.

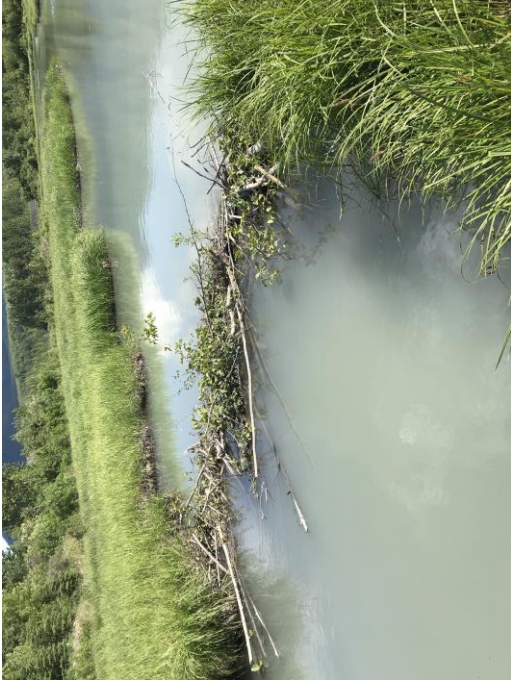
Unit 11.1 – Back Water Pool behind small
beaver dam

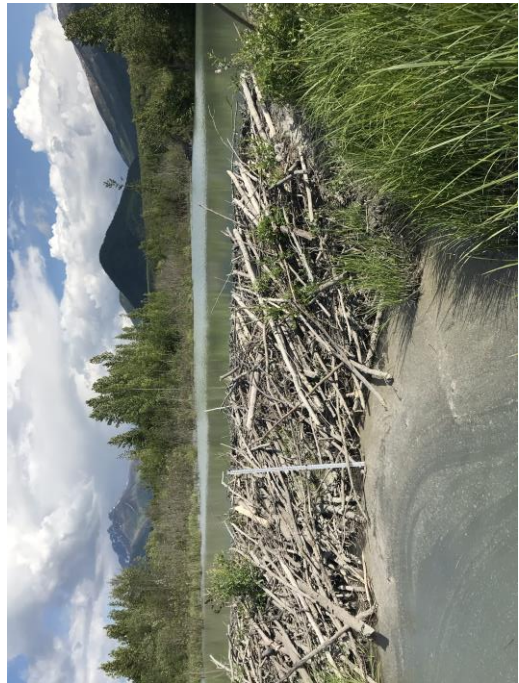
Unit 11.1.2 – Back water pool behind
large active beaver dam

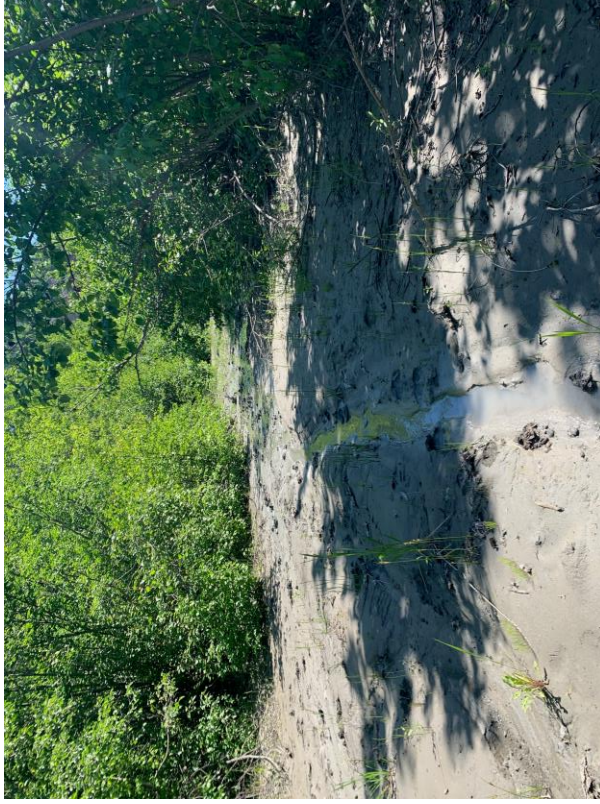
Unit 108.0 – Not Enough Water for a Decision

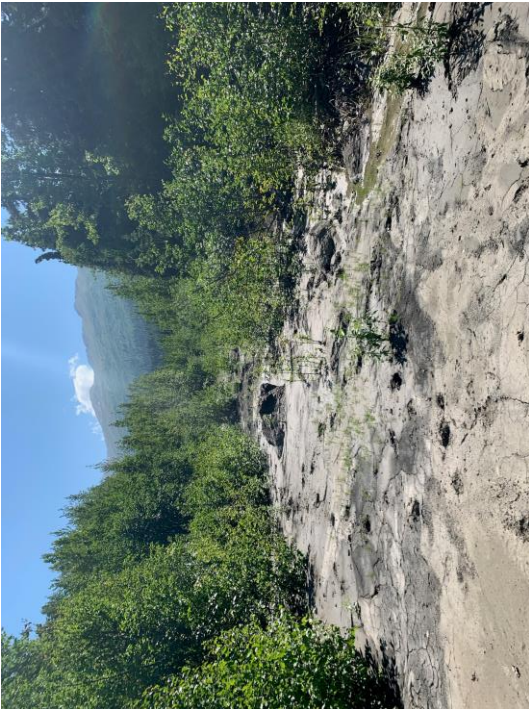
Unit 109.0 – dry channel

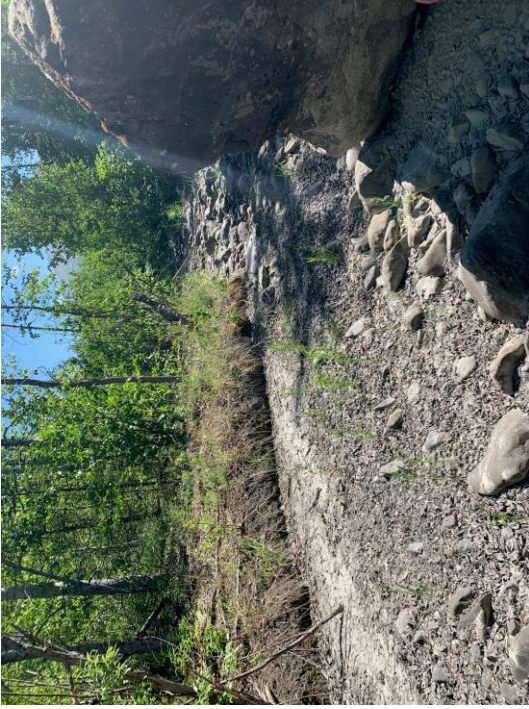
Unit 110.0 – Dry Channel

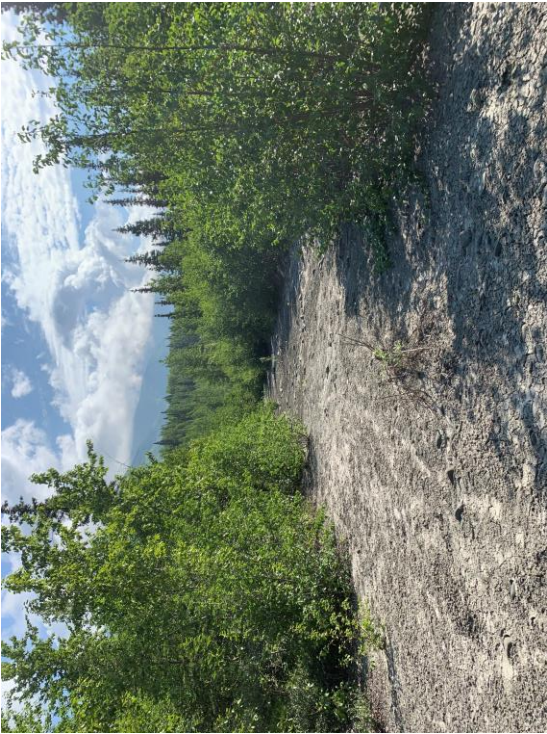
Unit 121.0 – dry channel

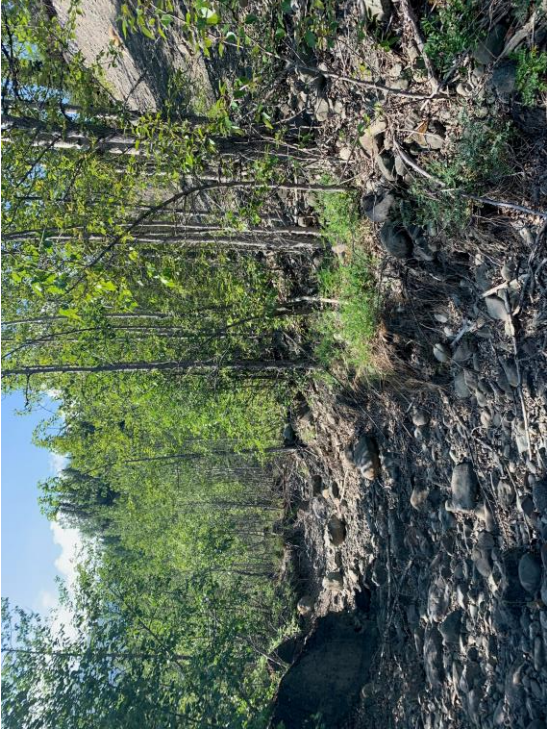
Unit 122.0 – dry channel

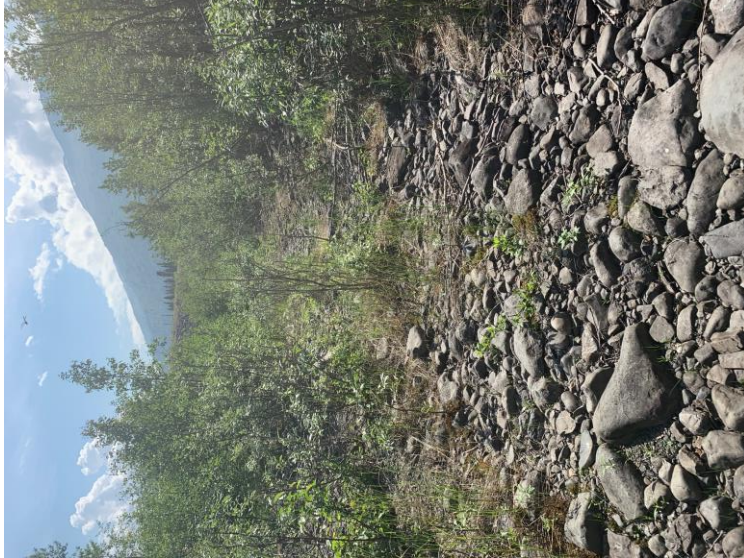
Unit 125.0 – dry channel
